# Fatigue Testing of Stiffened Traffic Signal Structures

Jay A. Puckett, Ph.D., P.E., M.ASCE<sup>1</sup>; Robert G. Erikson, Ph.D.<sup>2</sup>; and John P. Peiffer<sup>3</sup>

**Abstract:** Based on in-service inspection of poles with traditional designs, the inventory of Wyoming Department of Transportation (WYDOT) exhibited approximately a one-third cracking rate. A ring-stiffened connection is presently used. Sixteen fatigue tests were performed on 12 ring-stiffened cantilevered traffic signal pole connections to quantify the fatigue resistance. Two pole sizes were tested in three loading configurations: in plane, out of plane, and diagonal. Cyclic loading was applied to produce stress ranges (SRs) at several levels up to 16 ksi in the main member, more than six times the SR observed during monitoring an in-service pole. The WYDOT stiffened connection appears to be adequate to resist Wyoming's sustained winds that average approximately 12 mph in many locations. The possibility of using this connection with longer mast arms exists. Connection bolt fatigue failures were observed and may be the limiting fatigue design feature and important for inspection.

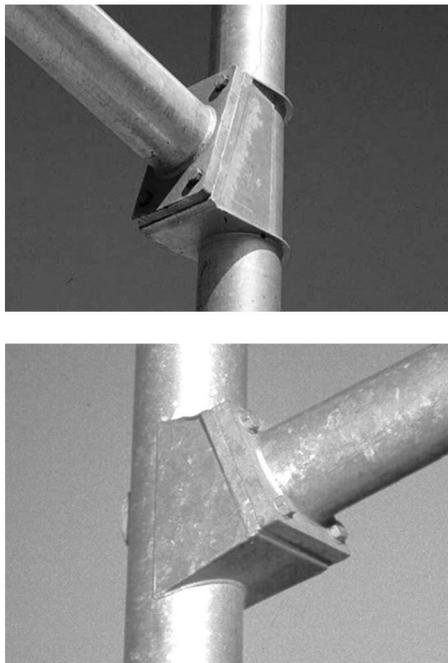
**Fig. 1.** Ring-stiffened connection, standard box connection

A MTS testing system using servocontrolled hydraulic actuators provided constant force amplitude cyclic loading. To determine the required testing load, a nominal bending stress calculation was done for each loading configuration at a point in the main member located 1 ft below the point of intersection of the main member and the branching member (hereafter referred to as the "design point") (see Fig. 1). Per AASHTO specifications, for an untested connection, the nominal stresses in the main member "just below the connection of the branching member" shall not exceed stress Category E (4.5 ksi). A distance of 1 ft for the design point was chosen for convenience and uniformity (see Fig. 1).

The applied loads were computed based on flexural stresses at the design point (see Fig. 1). The method of determining the applied testing force is consistent with procedures used for design (AASHTO 2001a,b). Axial and torsional stresses are neglected and, from detailed calculations, are shown to affect the total principal stresses by less than 5%.

(see Fig. 1). For the two tests that experienced connection fatigue failure, the data point was plotted at the number of cycles at which crack was first observed.

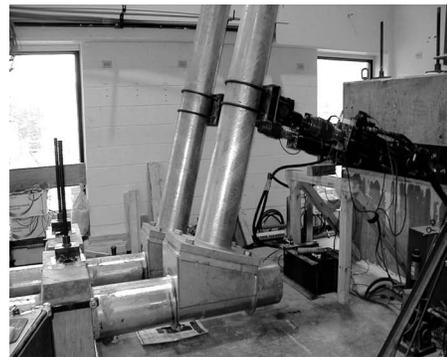
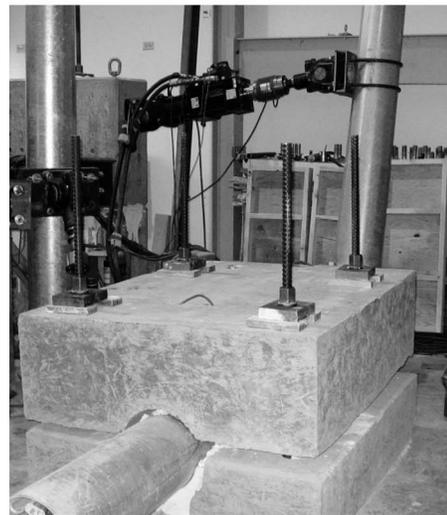
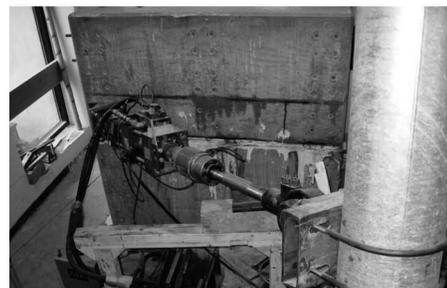
**Fig. 2.** In-plane, out-of-plane, and diagonal loading configurations

Cyclic loads were applied to the test specimens in three different configurations: in plane, out of plane, and diagonal (see Fig. 2). The loading configurations were chosen for several reasons. First, the AASHTO specifications require the calculation of design loads and moments in the in-plane and out-of-plane directions. Thus, a correlation exists between the testing loads and the design loads. Second, previous research at UW has shown that these laboratory loading configurations are representative of actual in-service conditions. In addition, the diagonal configuration represents the simultaneous effects of in-plane and out-of-plane service loadings, which may be critical to the fatigue resistance of box connections (Hamilton et al. 2002).

A typical in-plane setup is illustrated in Fig. 2(a). Notice that the pole is in a horizontal orientation and the mast arm is 15° from vertical. This pole orientation was used for the out-of-plane and diagonal test configurations as well. The actuator, for in-plane configurations, is at 90° to the arm, measuring from its unloaded (neutral) position. The moment arm is the distance from the actuator to the design point, measuring parallel to the axis of the pole.

An example of the out-of-plane setup is given in Fig. 2(b). Here, the moment arm is the vertical distance from the point of intersection of the actuator axis and arm axis to the centerline of the pole. The diagonal test configuration is shown in Fig. 2(c). Moment arm lengths varied between tests and are given for each test on their respective data sheets, and details of stress computations are provided by Peiffer et al. (2008).

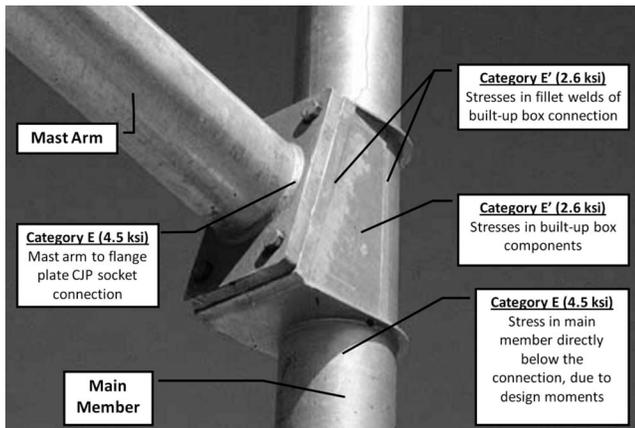
**Fig. 3.** AASHTO fatigue categories

available in the 2001 AASHTO specifications, and their application to cantilevered traffic poles with box connections is summarized in Fig. 3 and plotted in Fig. 8. An analysis of nominal stresses in the WYDOT box connection shows that the controlling stresses occur at the design point.

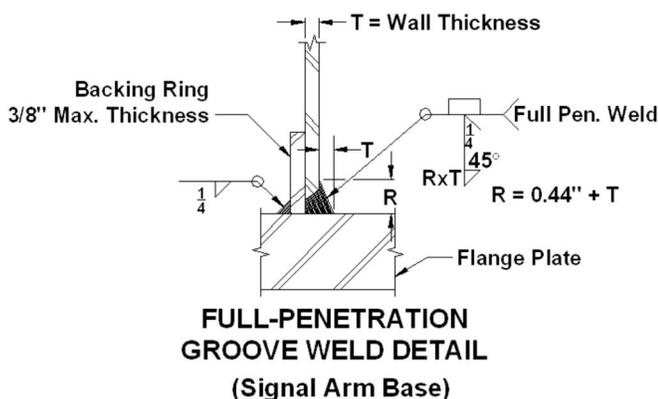
**Fig. 4.** Full-penetration groove weld detail between the arm and the flange plate (WYDOT 2005)

The secondary objective was to quantify the detail category of the CJP weld of the mast arms shown in Fig. 4. Three CJP joint failures plot above the detail stress Category D (see Fig. 12). The small arm, S-IP-001, that did not experience fatigue cracks accumulated over 43-million cycle plots above a CAFL Category E (4.5 ksi).

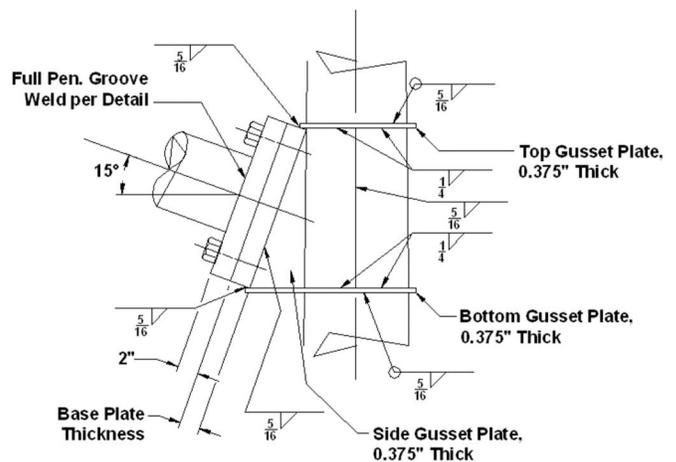
**Fig. 6.** Weld specifications for large and small box connections (WYDOT 2005)

For the circumferential fillet welds that were profiled, the WYDOT specification is a 5/16 in. fillet weld, noted in Fig. 6. The average actual fillet weld size of all specimens was 0.442 in., about 1/8 in. greater than specified. A comparison was done by measuring and averaging the throat distance of all of the specimens and dividing it by the cosine of 45° to obtain an equivalent fillet leg length. This method avoided an inaccurate direct fillet leg length measurement because many of the actual fillet profiles are concave in shape. A possible explanation for the deviation between actual and specified fillet sizes is Note 5 of the WYDOT specification, which states, “Ensure the radial separation between the face of the pole and the adjacent inside face of the top or bottom gusset plate does not exceed 3/16”. If the separation is greater than 1/16”, increase the leg of the fillet weld by the amount of the separation.” The gusset plate referred to in here is the stiffener ring. Thus, the actual fillet size is dependent on the supplier’s chosen process and tolerance for manufacturing the stiffener.

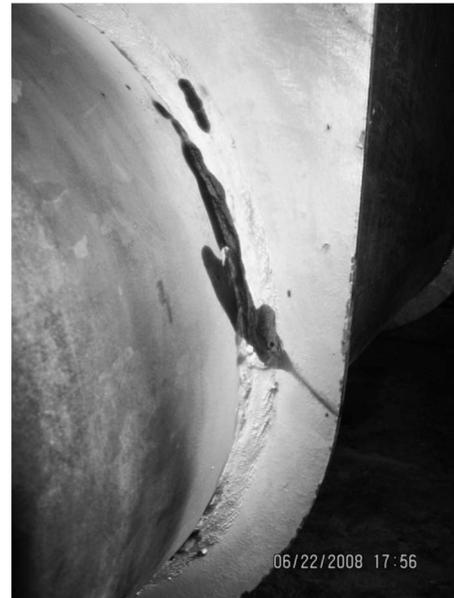
Fig. 7. Dye penetrant results of fillet weld joint failure, Test 11

be effective for traffic signal structures (Hamilton et al. 2002). However, the limitations of the procedure must be understood and the technique mastered to obtain reliable results. An example of a typical dye penetrant inspection is shown in Fig. 7.

For the diagonal test (see Fig. 7), the crack initiated at the toe of the weld and increased in length to 4 in. over 300,000 cycles. The stroke amplitude more than doubled as the crack increased to its full length. The crack did not follow the toe of the weld but propagated through the ring stiffener, thus accounting for the large increase in displacement during the pull stroke that opens the crack. For fatigue design considerations with the ring-stiffened WYDOT connection, test results indicate that out-of-plane and diagonal loadings are more severe than in-plane loading at the same SR.

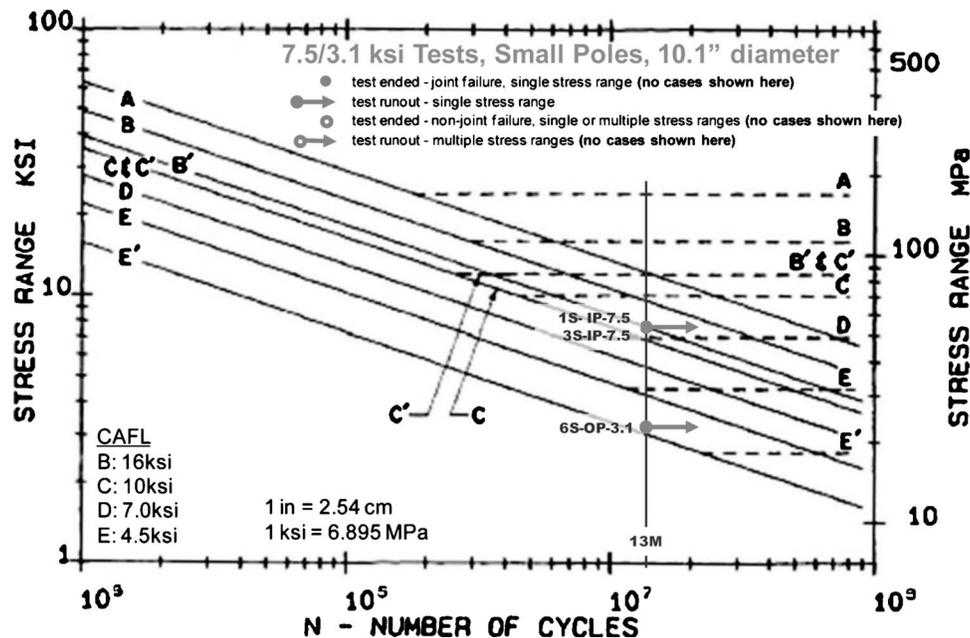
**Fig. 8.** Adjusted test data, small pole, 7.5/3.1 ksi

The CASR and total number of cycles for each specimen from Table 2 are plotted on AASHTO S-N charts in Figs. 8–11. The data points are for nominal bending stresses at the design point

For reference, a vertical line is marked at the 13-million cycle location. The outside diameter at the design point is provided on the charts. For readability, the pole test data are provided on four separate plots.

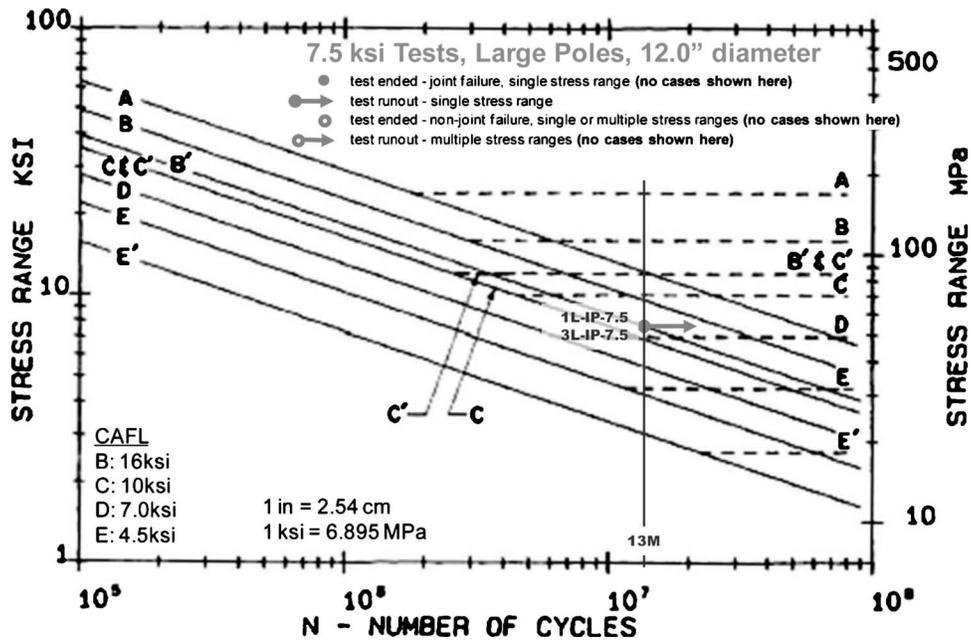
Fig. 9. Adjusted test data, large pole, 7.5 ksi

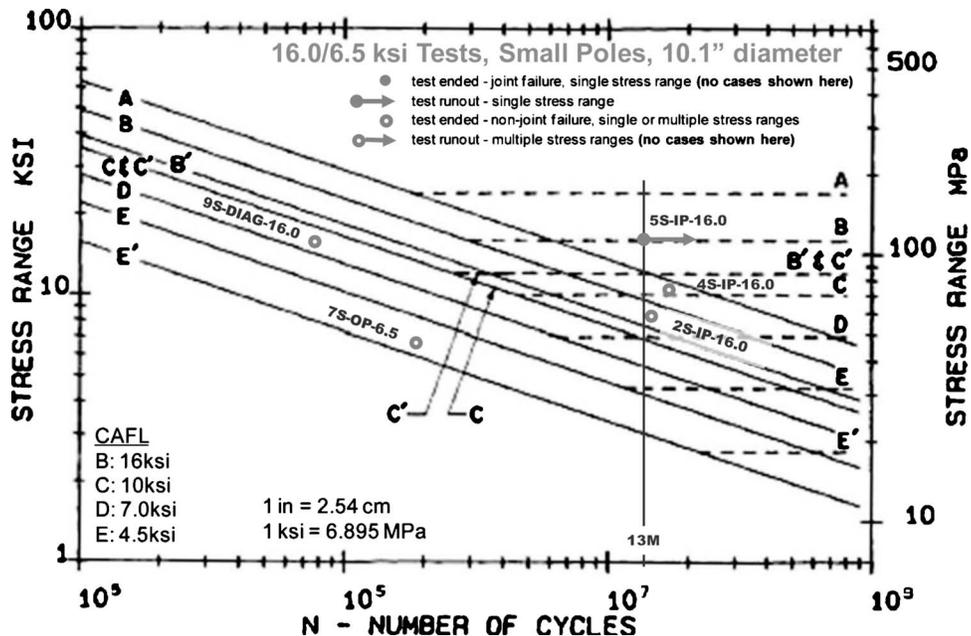
Fig. 10. Adjusted test data, small pole, 16.0/6.5 ksi

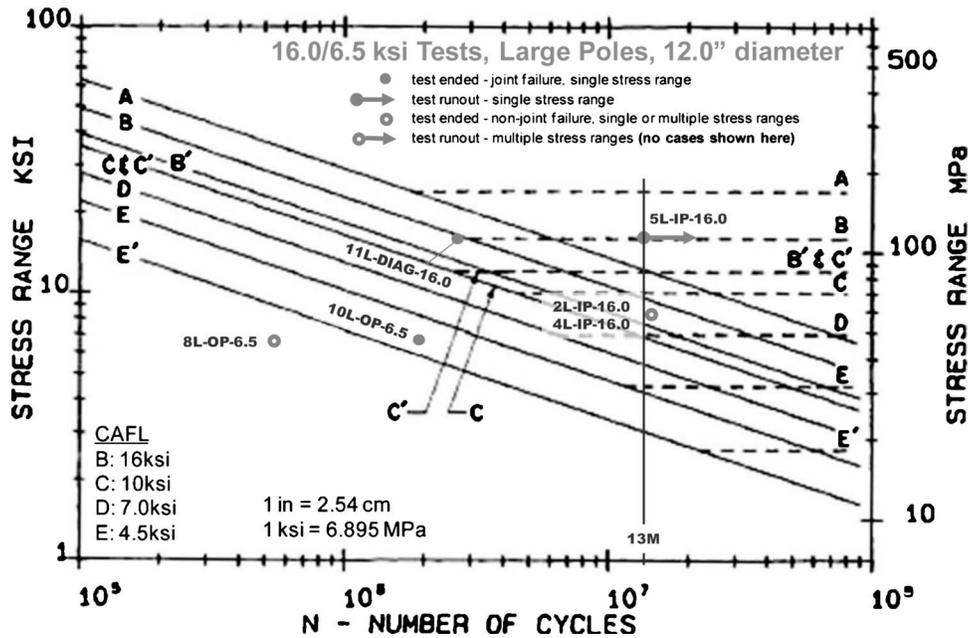
Fig. 11. Adjusted test data, large pole, 16.0/6.5 ksi

Thus, Test 8L-OP-6.5 (Fig. 11) is considered inconclusive.

Tests 2L-IP-16.0 and 4L-IP-16.0 (Fig. 11) provide useful information regarding the allowable stress of the detail because the number of test cycles places the data point in the infinite life region of the plot, and no fatigue cracks were observed.

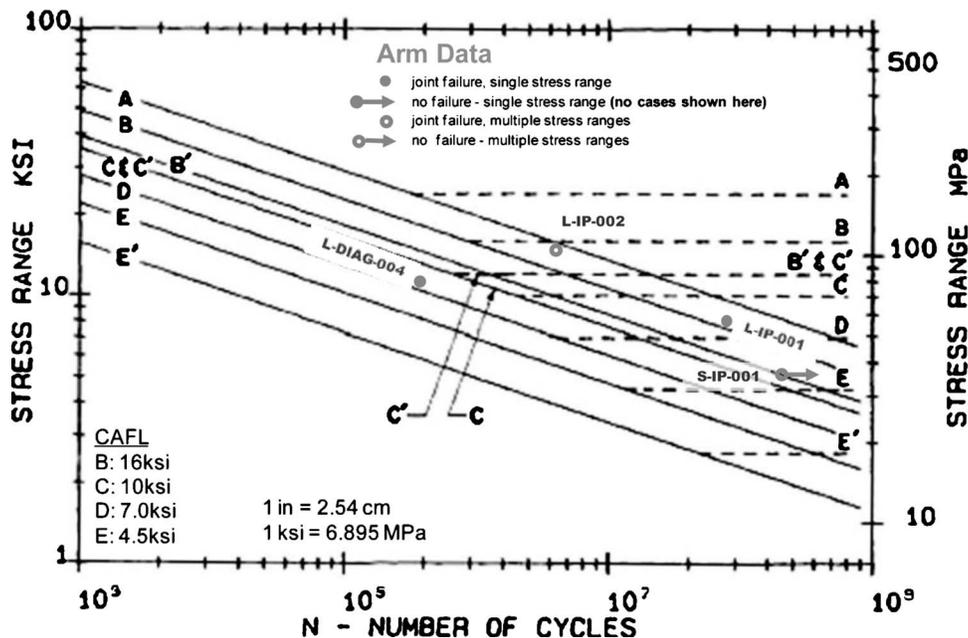
Fig. 12. Adjusted arm data

The adjusted arm data are plotted in Fig. 12, showing the three arms that failed due to fatigue (Table 4) and one that accumulated 43.5-million cycles and did not fail. The data points for the arms are for nominal bending stresses in the arm adjacent to the CJP weld.
